### Introduction RATH LLC

## Major Failure Modes of Refractories in Glass

# **Evaluating Refractory Material**

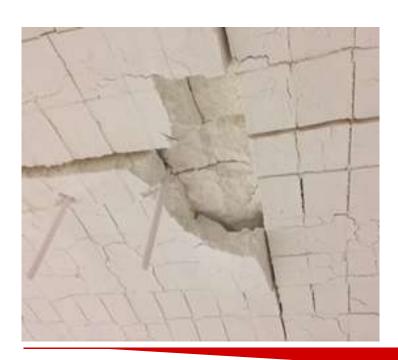
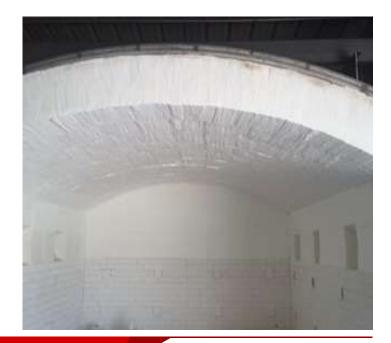
## Kiln modernization – No 7.

- Fiber Roof
- Open Front
- Quicker Loading
- Better Handling of Parts
- Less downtime for Repairs
- ◆ Longer life
